# **INDOOR AIR QUALITY ASSESSMENT**

**Mildred Elly Business School  
505 East Street  
Pittsfield, Massachusetts**

Prepared by:  
Massachusetts Department of Public Health  
Center for Environmental Health  
Bureau of Environmental Health Assessment  
Emergency Response/Indoor Air Quality Program  
August 2004

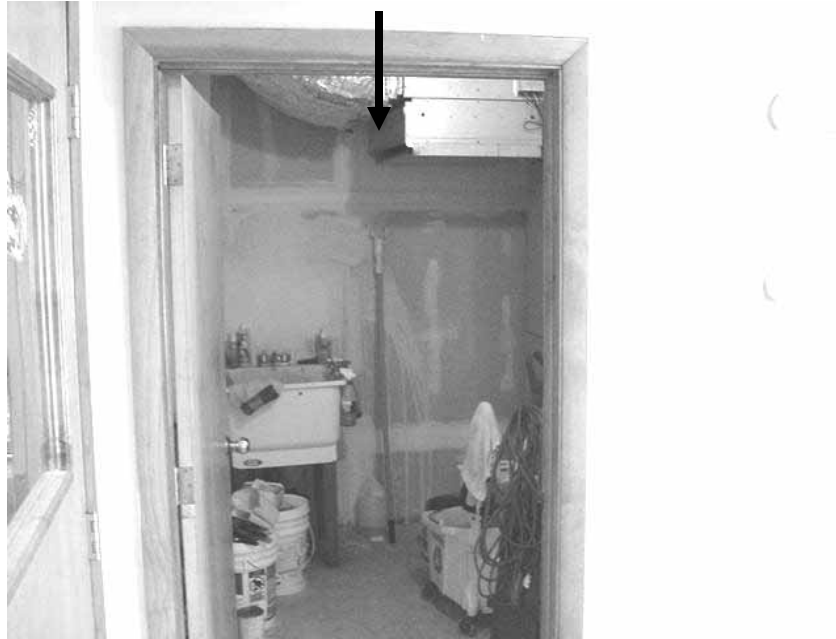
**Picture 1**

Ventilation is provided by a separate heating, ventilation and air-conditioning (HVAC) system on each floor. The first floor air handling unit (AHU) could not be accessed during the assessment. Ventilation on the first floor of the building appeared to be provided by a rooftop AHU that distributes fresh air through ducted ceiling diffusers. Ventilation is provided on the ground floor by an AHU located in a mechanical room

Several other conditions, which can affect indoor air quality, were noted during the assessment. In order to provide efficient combustion for the gas jet in the AHU, an adequate supply of combustion air is needed to provide oxygen. A combustion air vent is usually located in an area near this equipment. No make up air vent or ductwork that would provide combustion air could be identified. Without the introduction of air from the outside, air is drawn from the mechanical room and ultimately, from the ground floor area. In addition, the lack of oxygen may result in the production of incomplete combustion products, such as carbon monoxide. As previously mentioned, no measurable levels of carbon monoxide were detected during the assessment, however these results would be expected in a building with the AHU heating system *deactivated*. The presence of combustion products indoor may differ when the AHU system is *reactivated* in during the heating season.

Combustion Air Intake of AHU

**AHU in Mechanical Room on Ground Floor**

2. Contact an HVAC engineering firm and/or consult with the local fire prevention officer/building code officials to determine an appropriate method to provide combustion air for the AHU. A ducted mechanical fan may be necessary to introduce more fresh air. If not feasible, consider replacing the current AHU with an electric model.

5. Consider rendering the ground floor mechanical room as airtight as possible to eliminate the draw of combustion air from occupied areas. These measures would include:

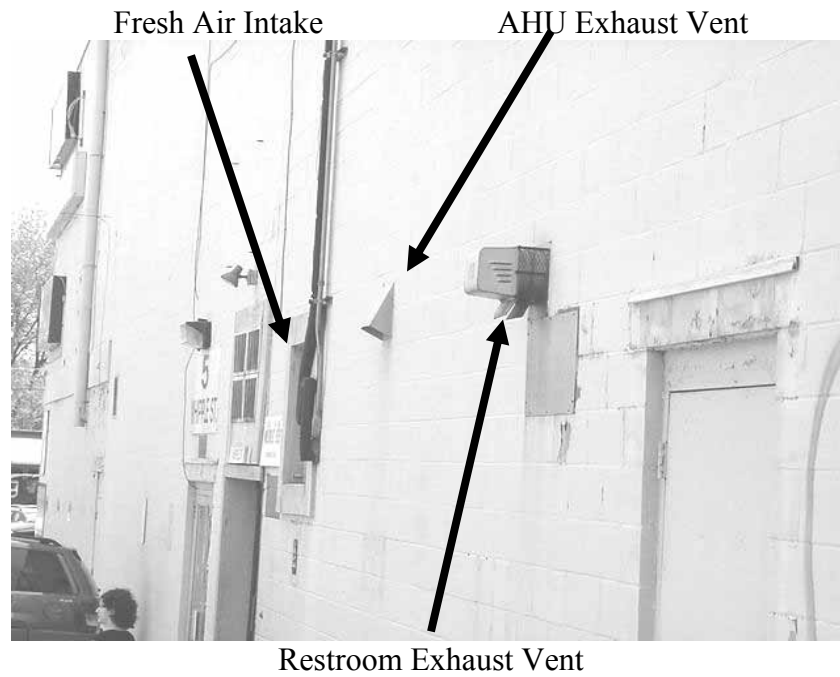
**Picture 2**

(Picture 1). Fresh air is drawn through a vent in the rear exterior wall of the building (Picture 2) and ducted to fresh air diffusers.

- A potential source of pollutants that is likely entrained by the HVAC system is the exhaust vent for the ground floor AHU gas burner. This exhaust vent is located in the rear wall of the MEBS at the same level as the AHU fresh air intake. If the gas burner were activated on the day of the assessment, the wind direction noted would carry products of combustion toward the fresh air intake, creating the opportunity for entrainment. The process of combustion produces a number of pollutants; however, the pollutant produced is dependent on the material combusted. Common combustion emissions include carbon monoxide, carbon dioxide, water vapor and smoke (fine airborne particle material). In the experience of BEHA staff, combustion product emissions can be described as having a “chemical-like” odor. Outdoor carbon monoxide concentrations were non-detect or ND. Carbon monoxide levels measured in the MEBS were also ND (Table 1).

**Fresh Air Supply Vent, AHU Exhaust Vent and Restroom Exhaust Vent on Rear Wall of MEBS Building**

3. Extend the exhaust vent for the ground floor AHU at least 10 feet above the level of the fresh air intake vent.
4. Conduct a building wide evaluation to determine whether business use or have processes that produce TVOCs that can be entrained by the general ventilation system. Either provide appropriate dedicated exhaust ventilation for TVOC using/producing activities, or consider prohibiting these activities.

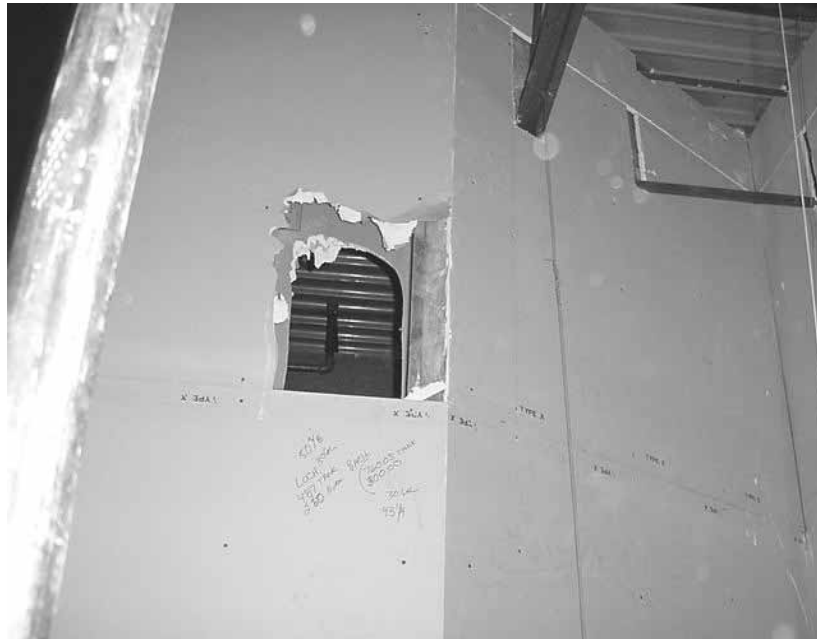
**Picture 3**

Return ventilation is dependent on the ceiling plenum (i.e., the space above the ceiling tile system). There is no ductwork in this type of system; air is drawn directly into the ceiling plenum and is returned to the AHUs. Holes are cut into interior walls above the ceiling tile system to allow airflow from classrooms back to the AHU (Picture 3). While return ventilation exists in classrooms, no means to exhaust air through the general ventilation system could be identified. With a lack of exhaust ventilation, existing pollutants inside the building are not removed and are continuously recirculated, which can lead to air quality/comfort complaints. This condition is significant with regard to odor complaints within this facility.

**Hole in Interior Wall on Ground Floor in Ceiling Plenum**

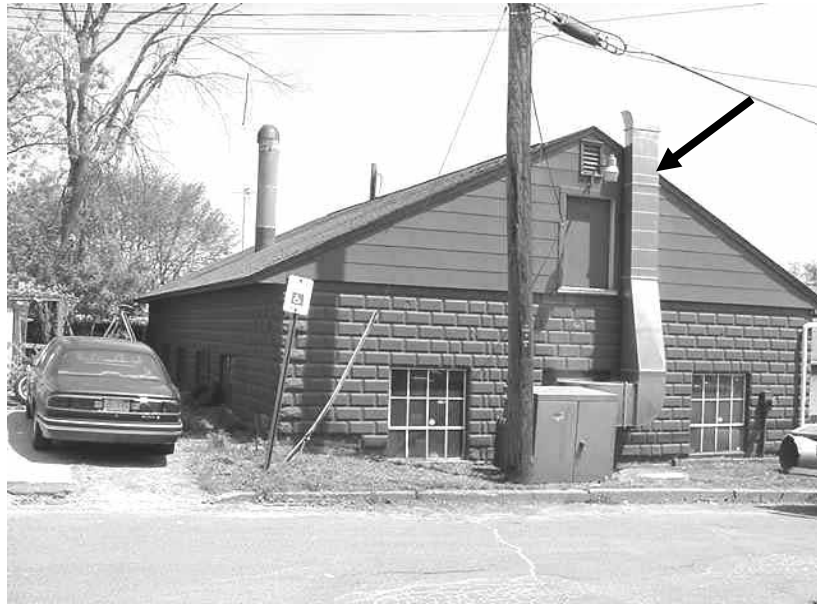
**Picture 4**

- The fresh air intake for the ground floor AHU is located approximately 6 feet above the ground. The terminus for the exhaust stack for the auto body shop is located over twenty feet above street level. The difference in height would tend to limit the amount of paint vapors at or near ground level.
- Except under unusual weather conditions, prevailing winds in Massachusetts tend to be from the west. As an example, moist weather tends to travel in a

**Auto Body Shop Located East of the MEBS Building, Note Exhaust Stack**
